NatureWalk Community Development District

**Board of Supervisors' Meeting
April 4, 2024**

COMMUNITY DEVELOPMENT DISTRICT AGENDA

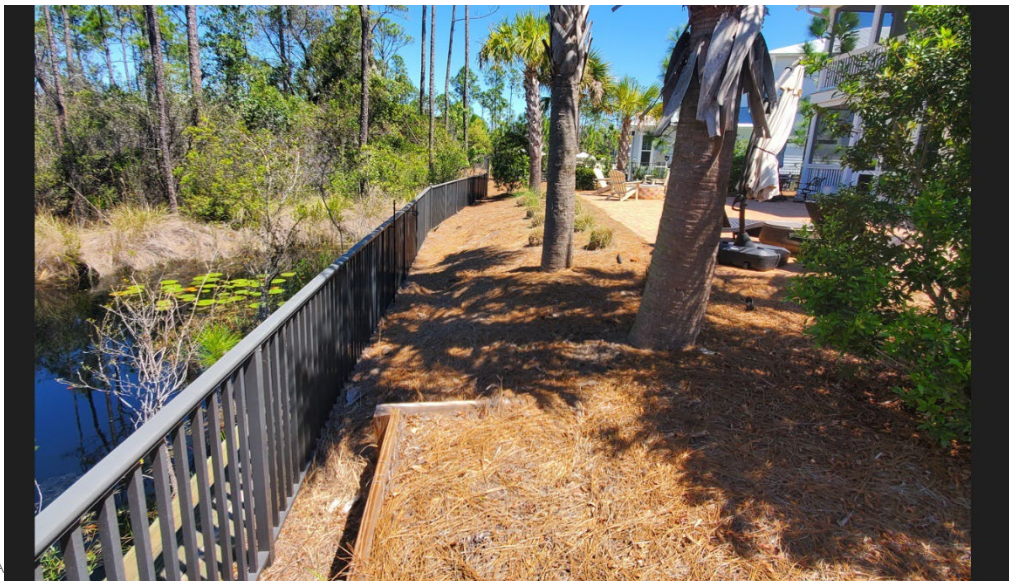
Innerlight Engineering Corporation (IEC) performed a site visit on March 28, 2024, to conduct an observation of the current ground surface conditions, specifically the area located between the rear yard of the aforementioned property and the pond wall. Below is a photo of the rear yard and pond wall.

We would recommend that the following approach be implemented to improve the situation and significantly deter or eliminate future erosion potential:

A Proposal was provided by Emerald Coast Scapes to repair and rectify the eroded area. Their proposal is dated February 14, 2024, and substantially includes the Engineer's recommendations identified above. We recommend the Board of Supervisors approved the proposal and associated scope of work.

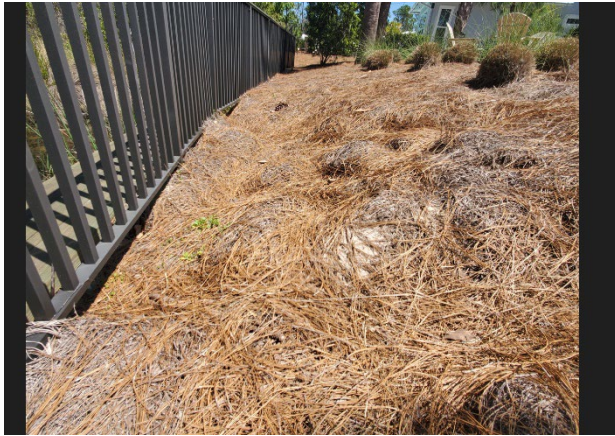
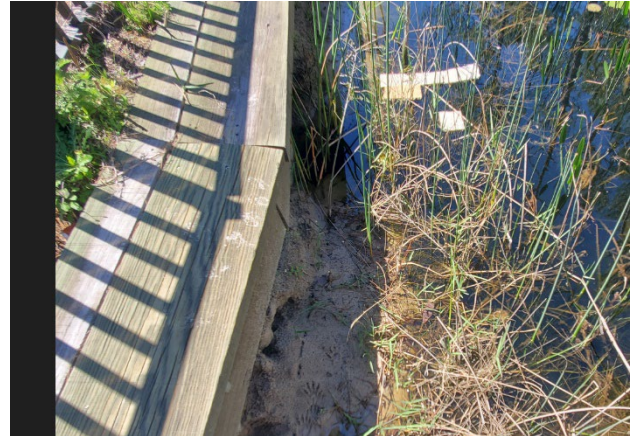
Based on an observation of existing conditions as discussed above and an assessment of the condition of the ground surface near and between the rear of the lot and the pond wall, it was observed that this area is experiencing significant erosion. The cause appears to be a combination of the sloped ground surface and gaps between the timber wall cap and the top of the sheet pile wall as well as there appears to be a couple unplugged, original lifting rings in certain locations of the sheet piles which soil can pass through. There is also evidence of some sediment which has breached the wall and deposited into Pond No. 24, from soil from the rear yard area discussed above. Below are a couple of recent photos of the erosive conditions.

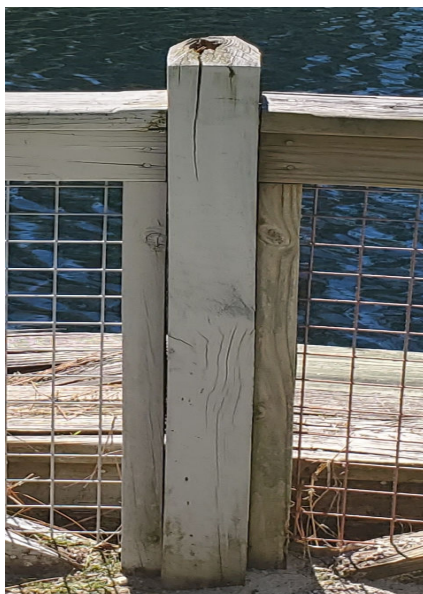
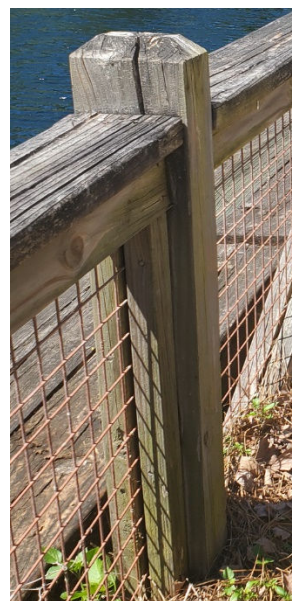
- Vertical Support Posts:
 - Firmly Positioned and Anchored
 - The Timber Material Condition was observed to be moderately weathered with some cracking, minimal splitting but still maintaining solid uniform composition.
 - Rating: Slightly to Moderately Deteriorated
 - Example Photos:

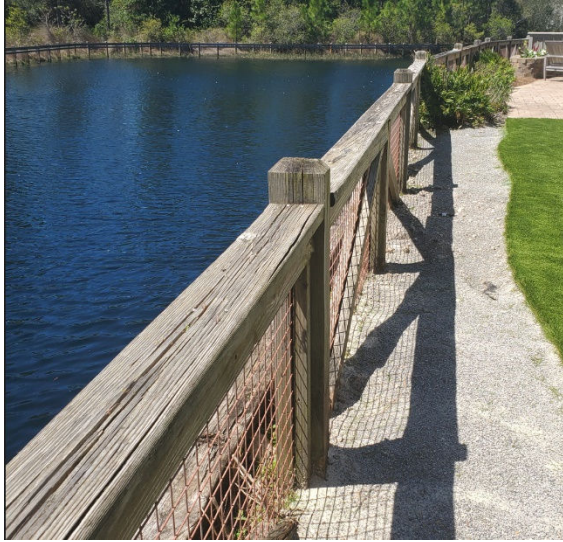
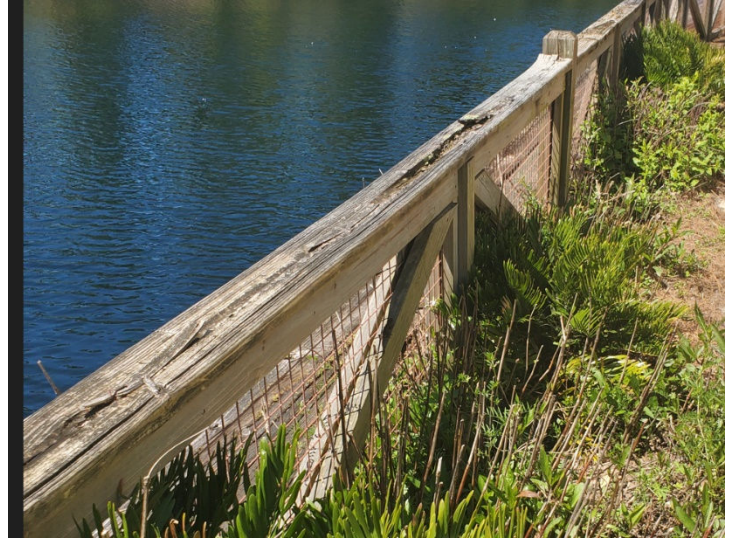
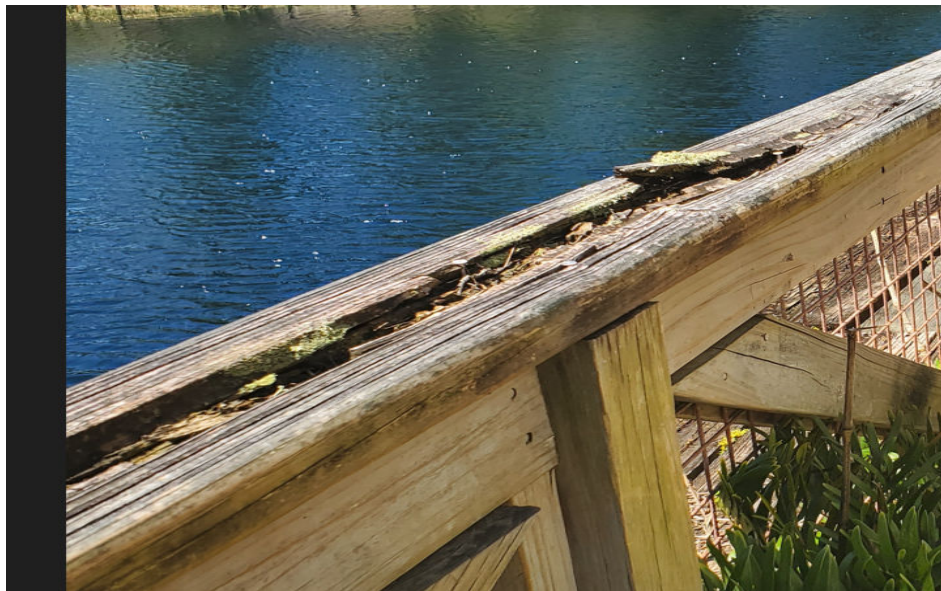
- Top Cap / Handrails:
 - Not Firmly Positioned and Anchored
 - The Timber Material Condition was observed to be severely weathered with Severe cracking and splitting and deterioration.
 - **Rating: Severely Deteriorated**
 - Example Photos:

- **Do Nothing (Not Recommended)**
 - This would leave the severely deteriorated handrail in place (not recommended)
- **Selective Board Replacement (Recommended)**
 - **Specific Replacement of Top Cap / Handrail and select cross bracing members.**
 - **Option Benefit(s): This option should result in the lowest cost to District at this time.**
 - **Option Weaknesses: Aesthetics / Will require further ongoing monitoring of remaining boards in near & mid-terms.**
- **Full Replacement (Not Recommended)**
 - This option would involve demolition and replacement of the entire fence and all components for the subject property.

Given the above discussion and the limited scope of work, IEC would recommend that the District implement the Selective option discussed above.

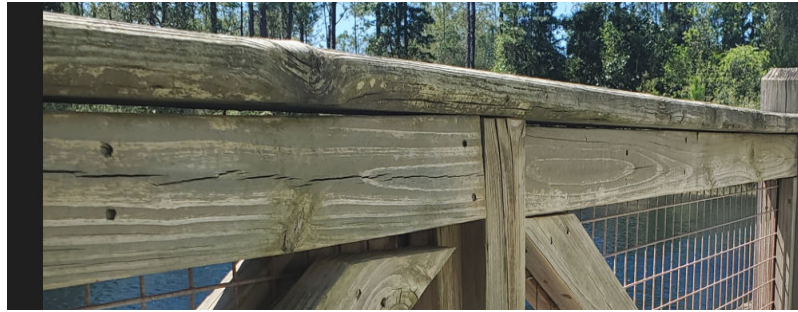
- Top Support Rails:
 - Mostly Firmly Positioned and Anchored
 - The Timber Material Condition was observed to be moderately weathered with some cracking, minimal splitting but still maintaining mostly solid uniform composition.
 - Fasteners were observed to be in various conditions, from nails popping out to nails fully seated.
 - Rating: Slightly to Moderately Deteriorated
 - Example Photo:

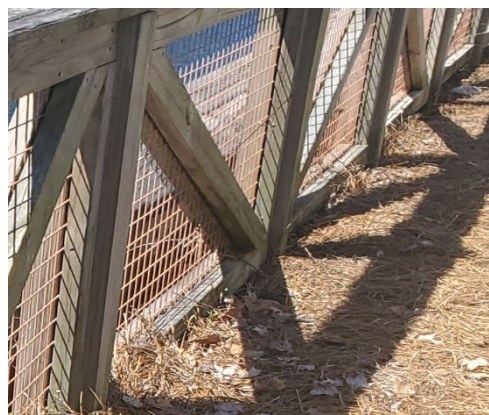
- Bottom Support Rails:
 - *NOTE: THE MAJORITY OF THE BOTTOM RAILS WERE COVERED BENEATH A CRUSHED STONE BASE MATERIAL AND WERE UNABLE TO BE OBSERVED, THE FEW THAT WERE VISIBLE, HAD BELOW CHARACTERISTICS:*
 - Mostly Firmly Positioned and Anchored
 - The Timber Material Condition was observed to be moderately weathered with some cracking, minimal splitting but still maintaining mostly solid uniform composition.
 - Fasteners were observed to be in various conditions, from nails popping out to nails fully seated.
 - Rating: Slightly to Moderately Deteriorated
 - Example Photos:

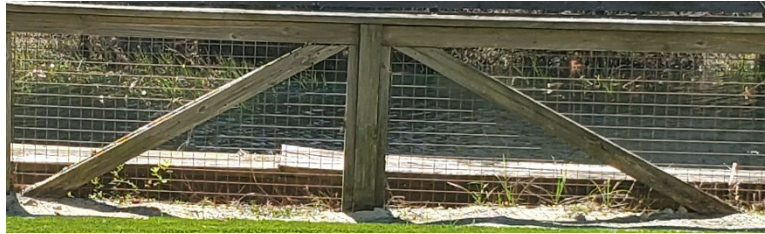
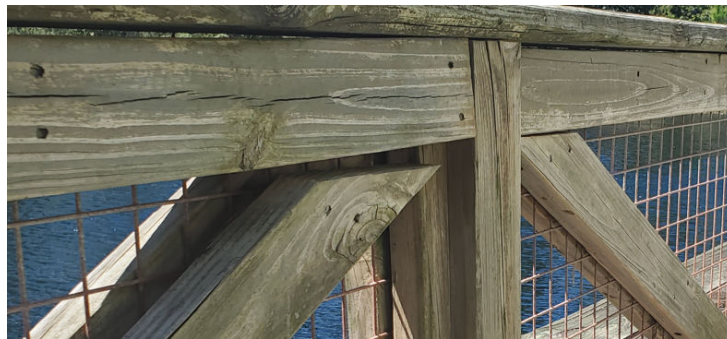
- Mostly Firmly Positioned and Anchored
- The Timber Material Condition was observed to be moderately weathered with some cracking, minimal splitting but still maintaining mostly solid uniform composition.
- Fasteners were observed to be in various conditions, from nails popping out to nails fully seated.
- Several Boards were separated and no longer connected to support posts.
- Rating: Slightly to Moderately Deteriorated

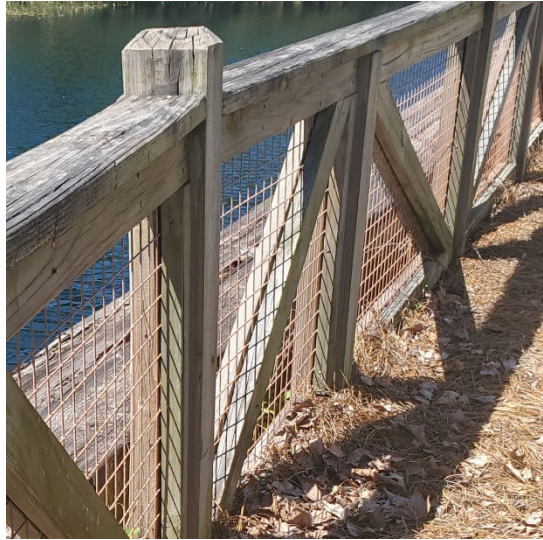
- Welded Wire Mesh:
 - Generally, properly positioned
 - Generally intact and free of breaks
 - Rating: Lightly Corroded
 - Example Photo:

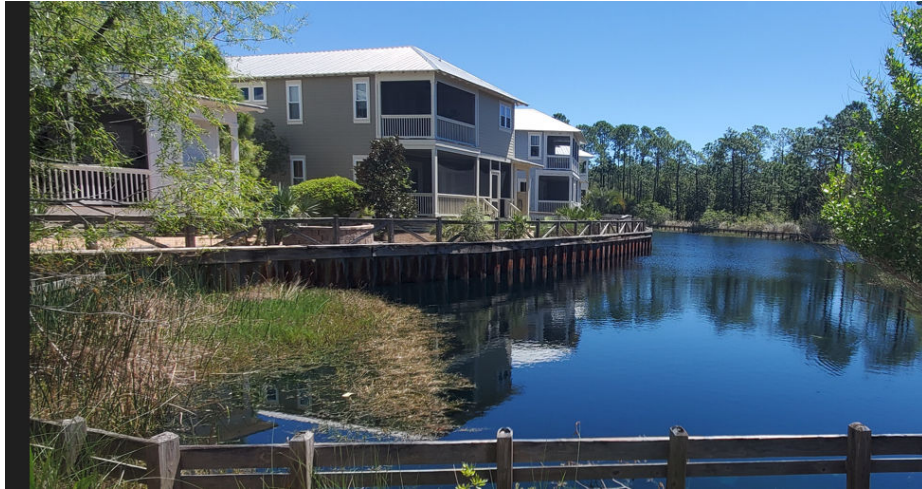
As noted above, an estimate of the distance between the fence and rear property lines has been depicted for general informational purposes only. This information was derived from the Master Plan CAD file and is approximate only and may vary. The property between the fence and referenced rear property lines is Owned by the Naturewalk Community Development District with one of the provisions of allowing operations and maintenance access to the Pond which is a regulated stormwater management facility. A photo of the fence line is provided below.

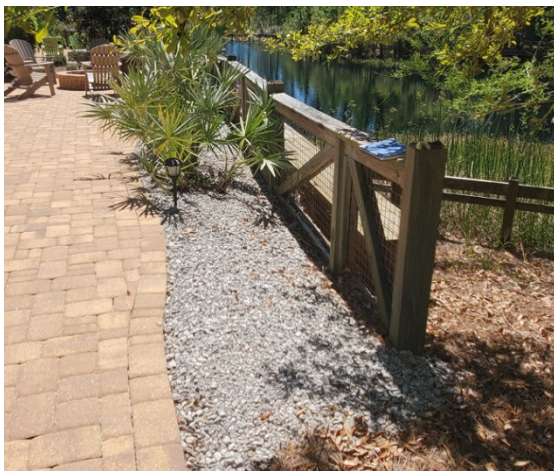
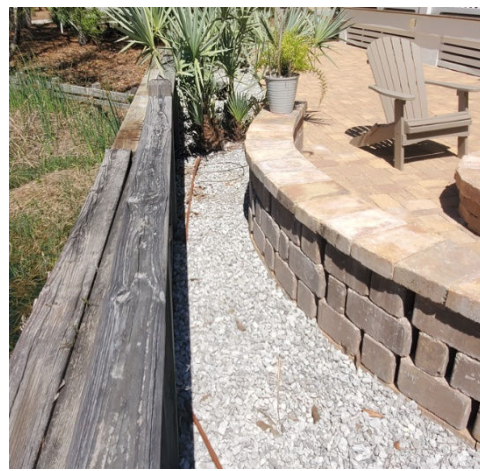
- 10 Salamander Court (Estimated Average Distance from Fence to Rear Property Line: 2-3 Feet):
 - The area includes crushed stone ground cover and multiple saw palmetto shrubs.
 - Near the Southeast corner of Lot there is a Patio Seating Wall, 2 to 3 feet from fence.
 - See Photos Below:

IEC would recommend that in order to verify any actual encroachments that a rear line survey by a qualified professional land surveyor be conducted to ascertain exact rear property limits and associated existing elements therein.

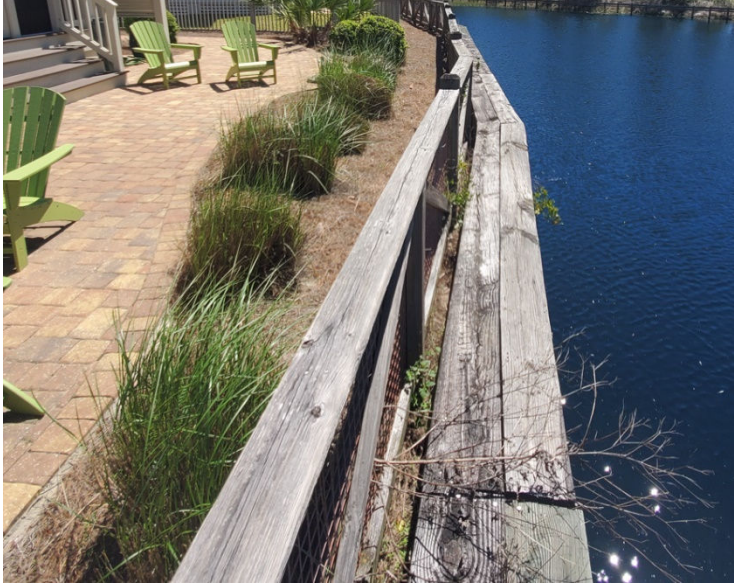
- 16 Salamander Court (Estimated Average Distance from Fence to Rear Property Line: 3.75 Feet):
 - The area includes pine straw ground cover and small grassy shrubs.
 - Patio pavers meander varying distances from fence.
 - See Photo Below:

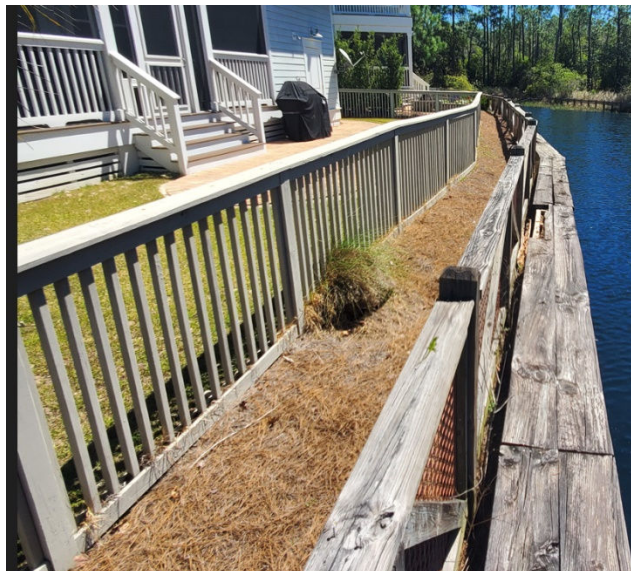
- 22 Salamander Court (Estimated Average Distance from Fence to Rear Property Line: 3.75 Feet)
 - The area includes pine straw ground cover and one loose small shrub.
 - There is a decorative rear property fence several feet away from pond fence.
 - See Photo Below:

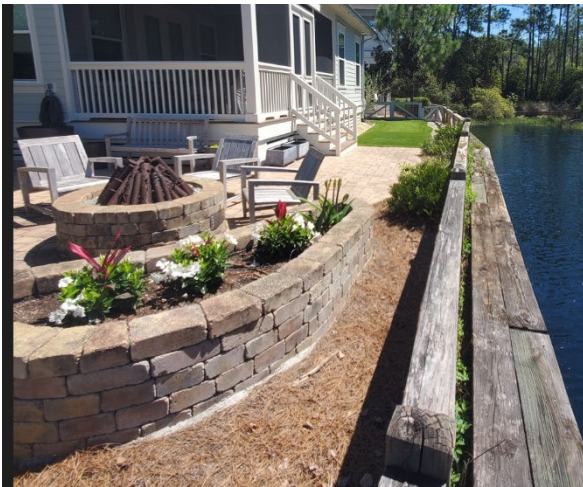
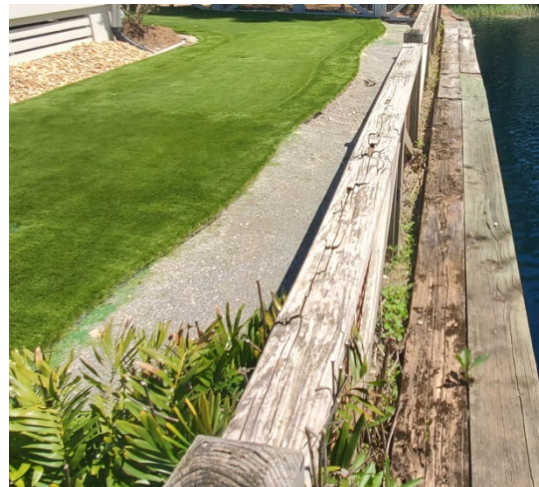
- 28 Salamander Court (Estimated Average Distance from Fence to Rear Property Line: 3.5 Feet)
 - The area includes multiple types of ground cover along rear property line as follows:
 - Pine straw mulch
 - Small shrubs
 - Crushed stone aggregate
 - Artificial turf
 - There is a decorative landscape stone planter box several feet from the fence.
 - See Photos Below:

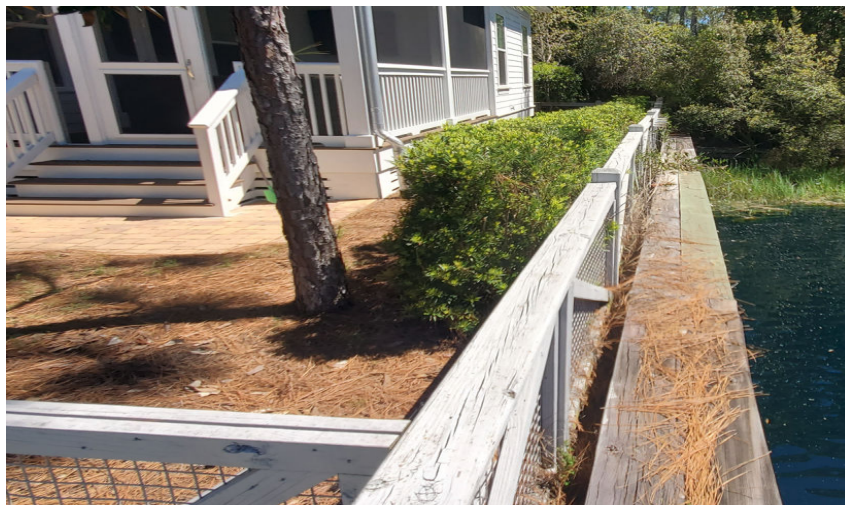
- 36 Salamander Court (Estimated Average Distance from Fence to Rear Property Line: 2.5-4 Feet)
 - The area includes pine straw mulch and Podocarpus Shrubbery directly adjacent to fence.
 - There is one pine tree a few feet from fence.
 - See Photo Below:
