# **NatureWalk Community Development District**

**Board of Supervisors' Meeting  
April 4, 2024**

- C. District Engineer ..... Tab 4
    1. Resolution of Pond 28 Beaver Dam, Habitat and Weir  
Reconstruction SOW
    2. Review of 1121 Sandgrass Erosion Repair by Emerald Coast Scapes

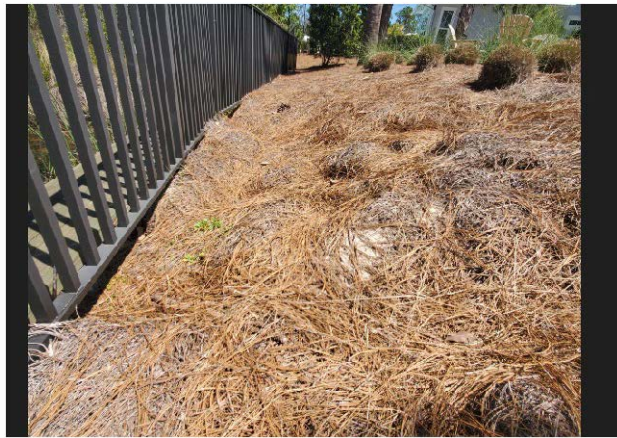
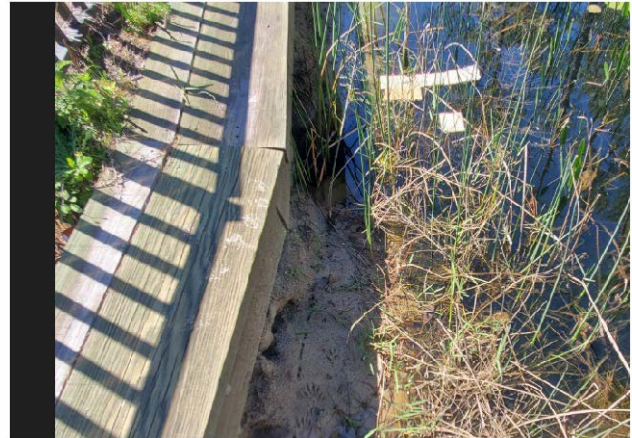
Based on an observation of existing conditions as discussed above and an assessment of the condition of the ground surface near and between the rear of the lot and the pond wall, it was observed that this area is experiencing significant erosion. The cause appears to be a combination of the sloped ground surface and gaps between the timber wall cap and the top of the sheet pile wall as well as there appears to be a couple unplugged, original lifting rings in certain locations of the sheet piles which soil can pass through. There is also evidence of some sediment which has breached the wall and deposited into Pond No. 24, from soil from the rear yard area discussed above. Below are a couple of recent photos of the erosive conditions.

We would recommend that the following approach be implemented to improve the situation and significantly deter or eliminate future erosion potential:

A Proposal was provided by Emerald Coast Scapes to repair and rectify the eroded area. Their proposal is dated February 14, 2024, and substantially includes the Engineer's recommendations identified above. We recommend the Board of Supervisors approved the proposal and associated scope of work.

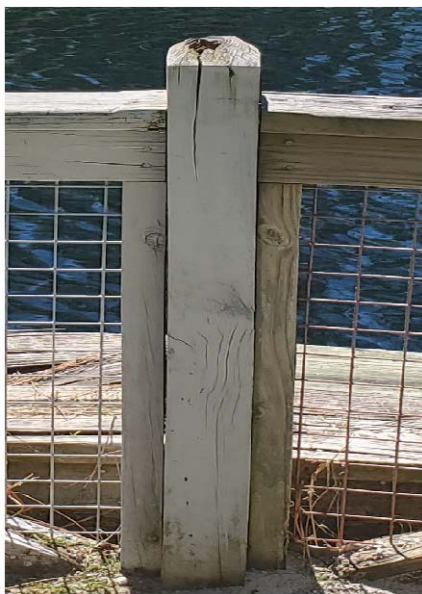
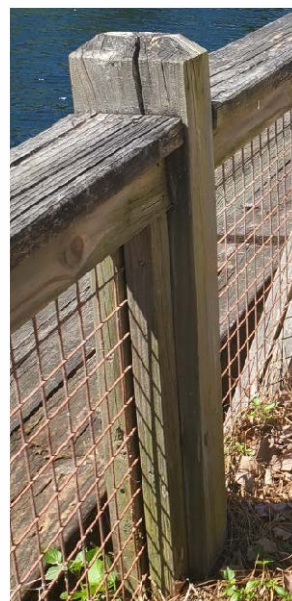
- Vertical Support Posts:
  - Firmly Positioned and Anchored
  - The Timber Material Condition was observed to be moderately weathered with some cracking, minimal splitting but still maintaining solid uniform composition.
  - Rating: Slightly to Moderately Deteriorated
  - Example Photos:

Based on an observation of existing conditions as discussed above and an assessment of the condition of the fencing components listed above, it is our opinion that most of the components are in satisfactory condition with the exception of the top cap / handrail. We would recommend the entire timber top cap / handrail be replaced with stainless steel screw anchors. We would also recommend replacement / reconstruction of several of the cross braces, particularly where the end have separated from support posts.

Given the above discussion and the limited scope of work, IEC would recommend that the District implement the Selective option discussed above.

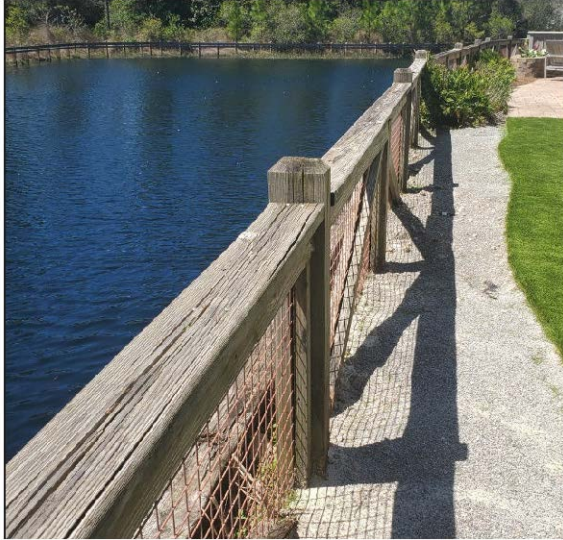
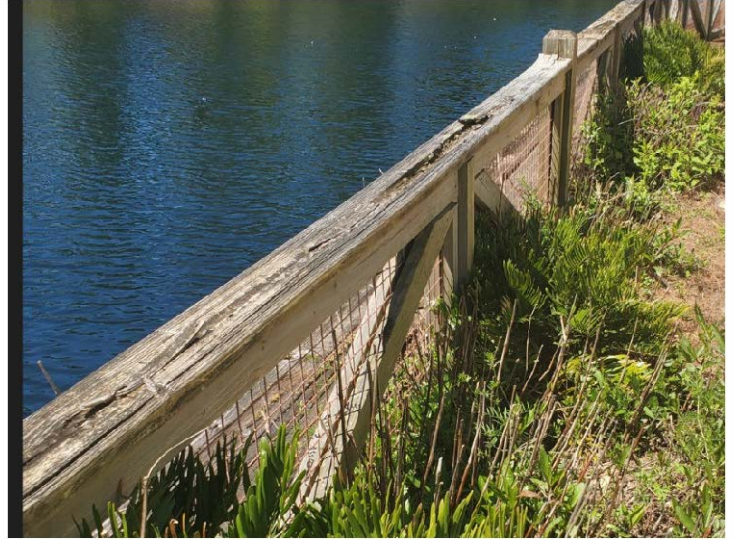
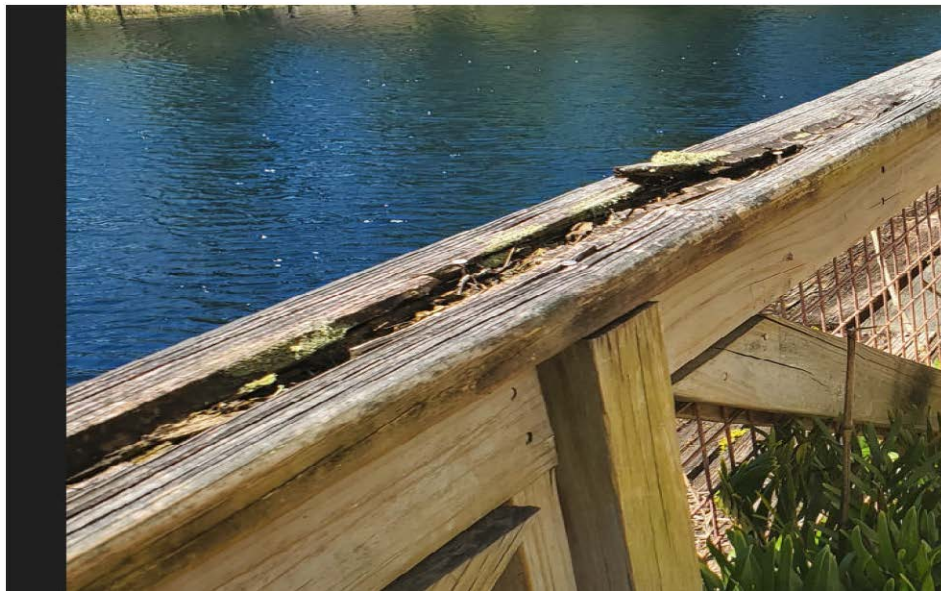
- Top Cap / Handrails:
  - Not Firmly Positioned and Anchored
  - The Timber Material Condition was observed to be severely weathered with Severe cracking and splitting and deterioration.
  - **Rating: Severely Deteriorated**
  - Example Photos:

- **Do Nothing (Not Recommended)**
  - This would leave the severely deteriorated handrail in place (not recommended)
- **Selective Board Replacement (Recommended)**
  - **Specific Replacement of Top Cap / Handrail and select cross bracing members.**
  - **Option Benefit(s): This option should result in the lowest cost to District at this time.**
  - **Option Weaknesses: Aesthetics / Will require further ongoing monitoring of remaining boards in near & mid-terms.**
- **Full Replacement (Not Recommended)**
  - This option would involve demolition and replacement of the entire fence and all components for the subject property.

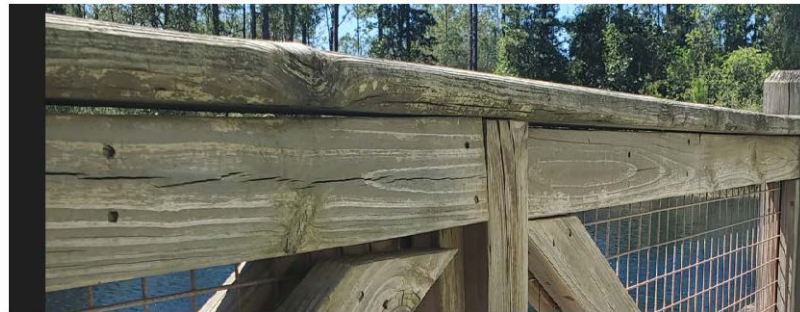
- Top Support Rails:
  - Mostly Firmly Positioned and Anchored
  - The Timber Material Condition was observed to be moderately weathered with some cracking, minimal splitting but still maintaining mostly solid uniform composition.
  - Fasteners were observed to be in various conditions, from nails popping out to nails fully seated.
  - Rating: Slightly to Moderately Deteriorated
  - Example Photo:

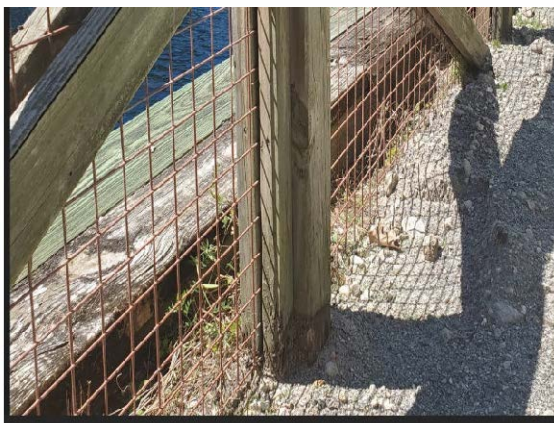
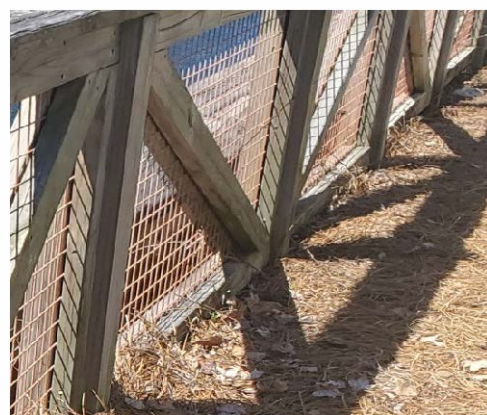
- Bottom Support Rails:
  - NOTE: THE MAJORITY OF THE BOTTOM RAILS WERE COVERED BENEATH A CRUSHED STONE BASE MATERIAL AND WERE UNABLE TO BE OBSERVED, THE FEW THAT WERE VISIBLE, HAD BELOW CHARACTERISTICS:
  - Mostly Firmly Positioned and Anchored
  - The Timber Material Condition was observed to be moderately weathered with some cracking, minimal splitting but still maintaining mostly solid uniform composition.
  - Fasteners were observed to be in various conditions, from nails popping out to nails fully seated.
  - Rating: Slightly to Moderately Deteriorated
  - Example Photos:

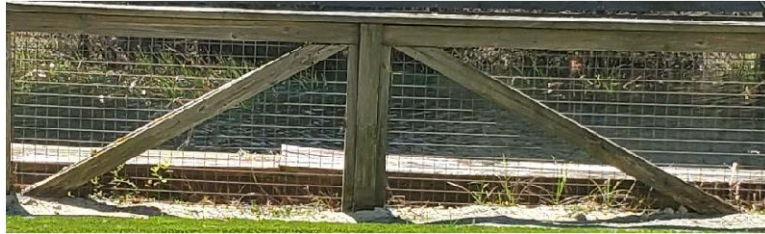
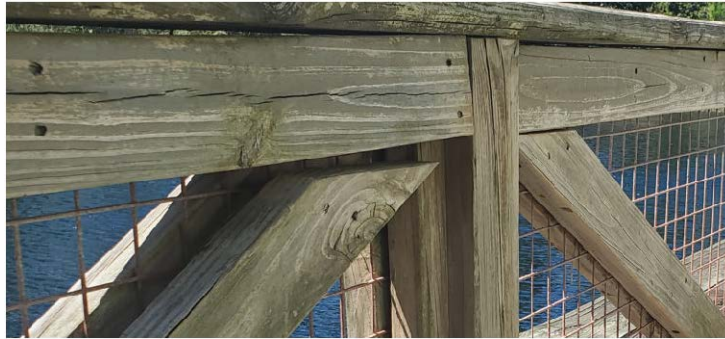
- **Angled Cross Bracing Boards:**

- Mostly Firmly Positioned and Anchored
- The Timber Material Condition was observed to be moderately weathered with some cracking, minimal splitting but still maintaining mostly solid uniform composition.
- Fasteners were observed to be in various conditions, from nails popping out to nails fully seated.
- Several Boards were separated and no longer connected to support posts.
- Rating: Slightly to Moderately Deteriorated

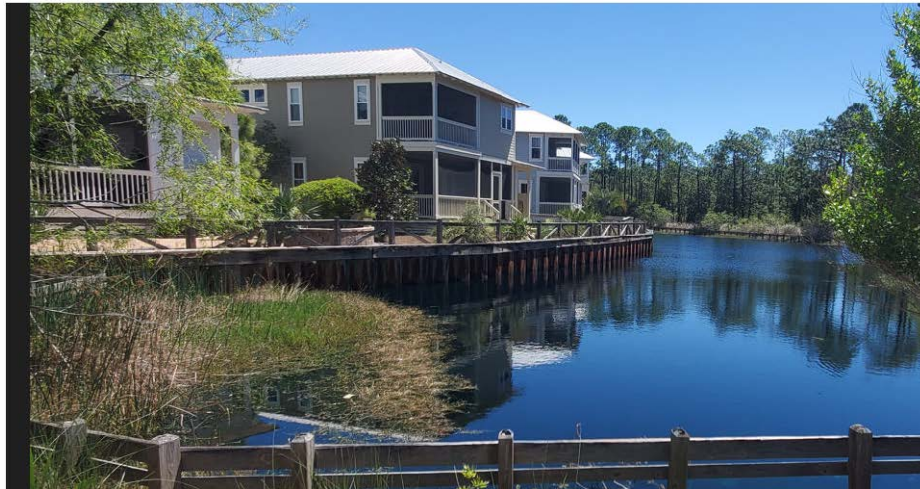
As noted above, an estimate of the distance between the fence and rear property lines has been depicted for general informational purposes only. This information was derived from the Master Plan CAD file and is approximate only and may vary. The property between the fence and referenced rear property lines is owned by the Naturewalk Community Development District with one of the provisions of allowing operations and maintenance access to the Pond which is a regulated stormwater management facility. A photo of the fence line is provided below.

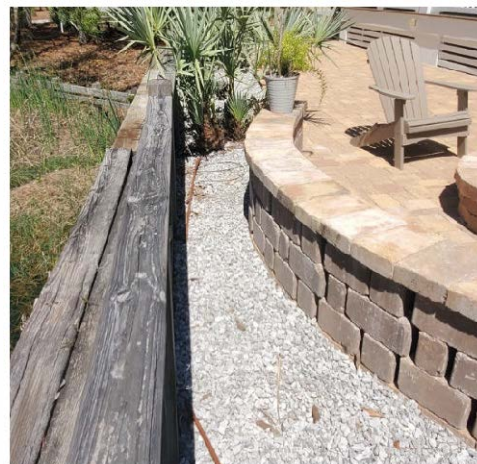
- 10 Salamander Court (Estimated Average Distance from Fence to Rear Property Line: 2-3 Feet):
  - The area includes crushed stone ground cover and multiple saw palmetto shrubs.
  - Near the Southeast corner of Lot there is a Patio Seating Wall, 2 to 3 feet from fence.
  - See Photos Below:

IEC would recommend that in order to verify any actual encroachments that a rear line survey by a qualified professional land surveyor be conducted to ascertain exact rear property limits and associated existing elements therein.

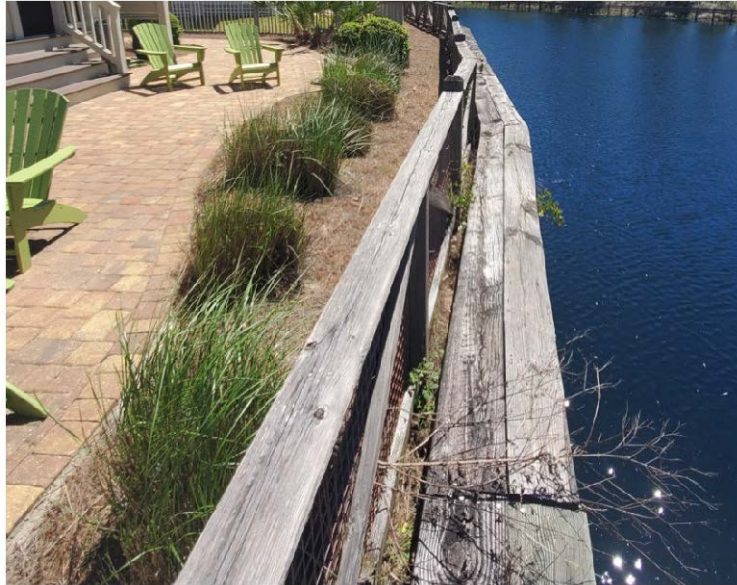
- 16 Salamander Court (Estimated Average Distance from Fence to Rear Property Line: 3.75 Feet):
  - The area includes pine straw ground cover and small grassy shrubs.
  - Patio pavers meander varying distances from fence.
  - See Photo Below:

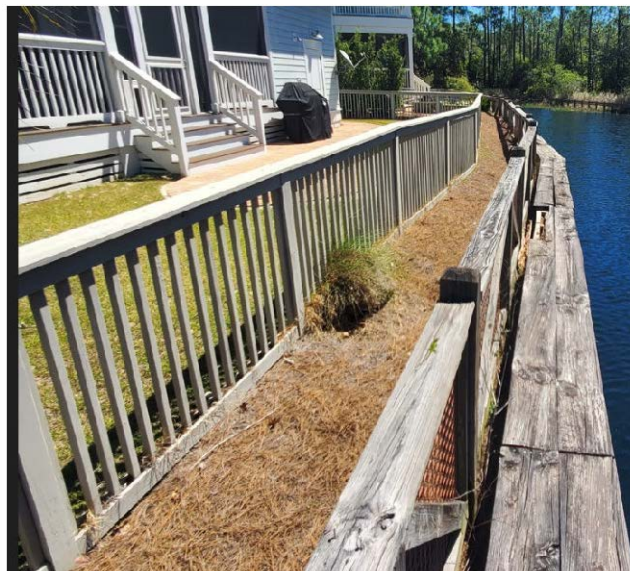
- 22 Salamander Court (Estimated Average Distance from Fence to Rear Property Line: 3.75 Feet)
  - The area includes pine straw ground cover and one loose small shrub.
  - There is a decorative rear property fence several feet away from pond fence.
  - See Photo Below:

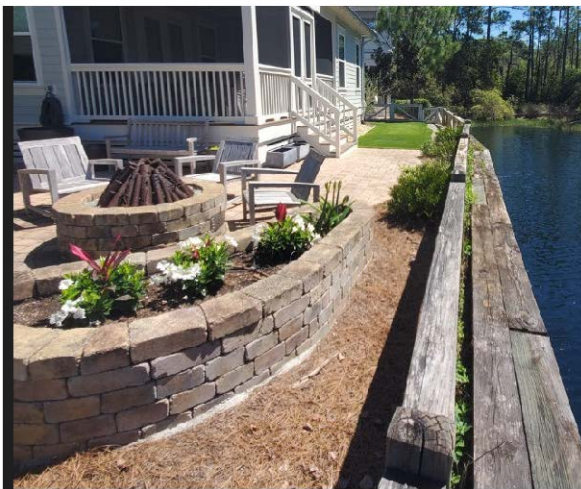
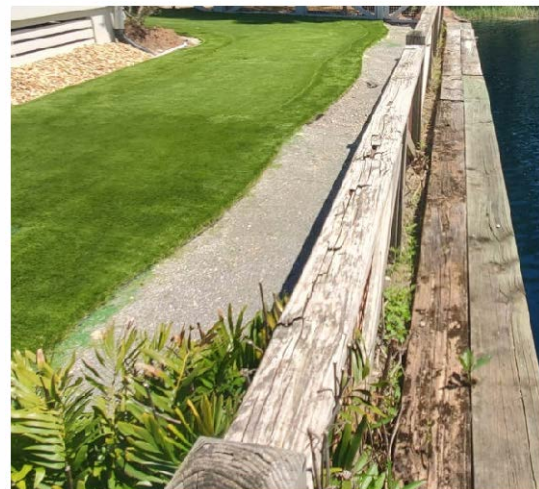
- 28 Salamander Court (Estimated Average Distance from Fence to Rear Property Line: 3.5 Feet)
  - The area includes multiple types of ground cover along rear property line as follows:
    - Pine straw mulch
    - Small shrubs
    - Crushed stone aggregate
    - Artificial turf
  - There is a decorative landscape stone planter box several feet from the fence.
  - See Photos Below:

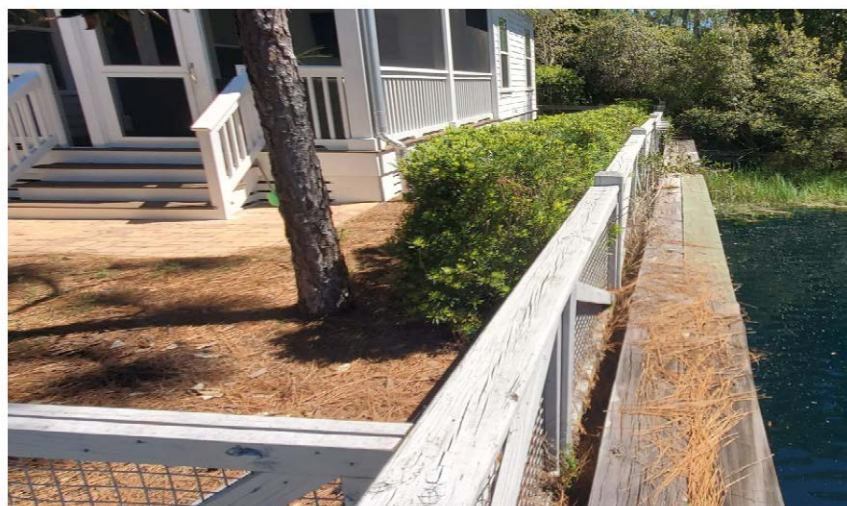
- 36 Salamander Court (Estimated Average Distance from Fence to Rear Property Line: 2.5-4 Feet)
  - The area includes pine straw mulch and Podocarpus Shrubbery directly adjacent to fence.
  - There is one pine tree a few feet from fence.
  - See Photo Below:
